The Effect of Slurry Type on Drilled Shaft Cover Quality

ABSTRACT

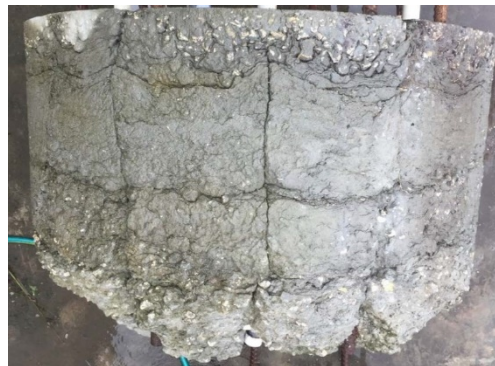
Figure 3: Mattressing in a drilled shaft

like oil over water but rather builds-up a certain amount of head inside the cage prior to pushing through the reinforcing cage in a radial flow pattern. (Deese and Mullins, 2005; Brown, 2004) Deese and Mullins showed the height of concrete buildup inside the cage was proportional to the square of upward velocity and inversely proportional to the clear rebar spacing (Figure 1). As the concrete flows through the reinforcement cage it is cleaved by the vertical and horizontal rebar and then rejoins on the outside of the cage. This provides an inherent opportunity for laterally forming laitance interfaces to become trapped creating a crease (Figure 2). These creases often extend to the surface and reflect the reinforcement cage layout (Figure 3); this phenomenon is termed *mattressing* by the Deep Foundations Institute (Beckhaus, 2016).

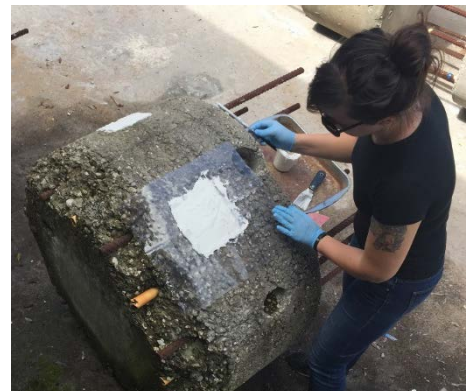
Physical Measurements: The surface roughness was assessed by measuring the volume of putty required to fill the surface voids (Costello et al., 2017). The void volume was measured at two representative areas by recording the weight of the putty, with known density, required to make the surface smooth. This volume was then extrapolated to approximate the void volume for the entire shaft surface. This assumed the original outer surface of the shaft had not undergone severe radial reduction and that the putty would produce a smooth surface representative of an undamaged shaft surface (Figure 4).

Figure 4: Putty void volume test

Physical Void Volume: Void volume was computed for two test areas on each shaft, the results were then averaged and extrapolated over the entire shaft surface (Table 1). The values range from 38 to 592in³. Note 24-B40, SCC was not tested due to severe surface degradation.

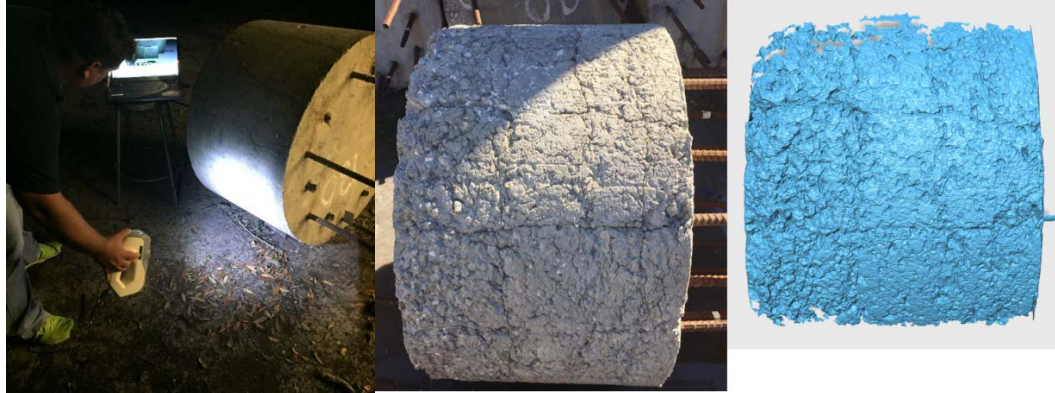
Digital Scanning: One side of each shaft was also scanned using an Artec Eva 3D scanner which produced a digital rendering of the shaft surface down to 10 micron accuracy (Figure 5). The three dimensional surface was analyzed using the corridor modeling tools in AutoCAD Civil3D to determine the volume required to restore a smooth surface. This required robust computational capabilities to handle the 3-5 million data points; only three of the shafts are presented herein.

Figure 5: Scanning specimen (left), shaft photo (center), digital rendering (right).

Digital Void Volume: The digital void volume method superimposes a perfect shaft surface over the digitally recorded 3-D shaft surface. It uses the highest measured points within the selected area to determine the ideal curved shaft surface. The volume required to fill the digitally measured surface up to the ideal surface was then recorded. Digital surface void volume determination resulted in higher quantities than the physical method (Table 2). This could be due to the reference ideal surface used and the physical void volume ideal surface is created without a template and as such is left to the judgement of the technician performing the test. The percent difference shown below illustrates the conservative nature of the physical method.

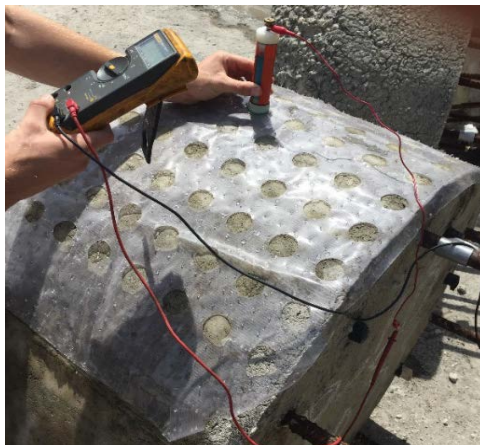
Surface potential measurements are a strong indicator of active corrosion within a reinforced concrete structure. This test is performed by measuring the relative voltage potential between the reinforcing steel and a copper-copper sulfate electrode in wetted contact with the concrete surface several inches away from the reinforcing steel (ASTM, 2009). When the measured potential is more negative than -350mV there is a high probability of corrosion.

Figure 6: Surface potential testing

The surface potential of each shaft specimen was mapped evenly over the surface using a prescribed grid layout. A template was made out of sheet of 21-inch by 27-inch rubberized plastic. A sharpened 2-inch diameter pipe was used to punch holes through the plastic in rows with a 3-inch CTC spacing in both directions. This resulted in 80 measurement locations for each shaft. The shafts were wetted and surface potential testing was then conducted per ASTM C876-09: *Standard Test Method for Corrosion Potentials of Uncoated Reinforcing Steel in Concrete*, using a copper-copper sulfate reference electrode and a standard multi-meter (Figure 6).

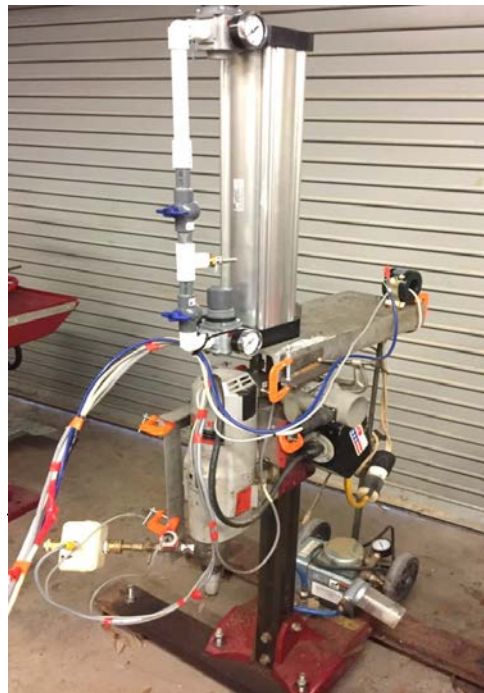
A fully instrumented coring machine, hereafter referred to as a concrete penetrometer, was developed to record variations in concrete strength while collecting a core sample (Figure 7). The penetrometer computes strength (f'_c) by eliminating variables in two torque equations: mechanical and electrical. Measured parameters include: crowd, rpm, torque, displacement, cutting fluid flow rate and fluid pressure. Complete details of the instrumentation and data analysis can be found elsewhere (Costello et al., 2017).

Figure 7: Concrete Penetrometer

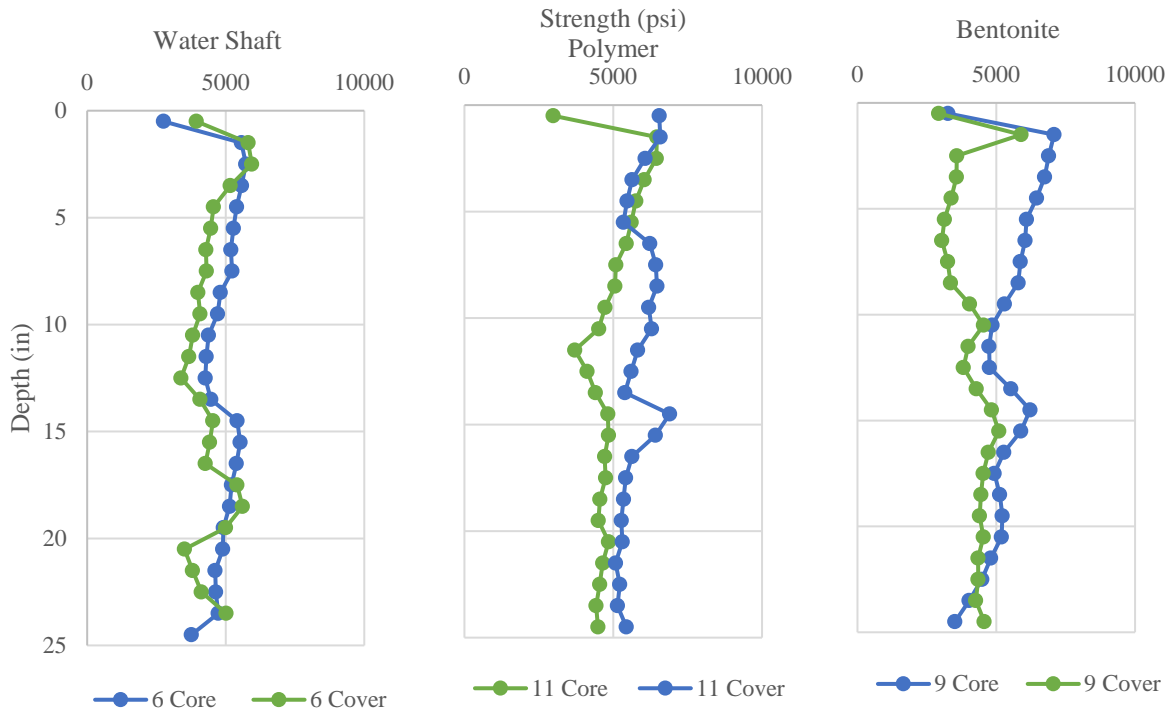
Strength Profiles: Concrete penetrometer testing was performed in four locations on each of three subject shafts, two in the core and two in the cover. Figures 9,10 and 11 show the average cover and core strengths for a water, polymer and bentonite shaft, respectively.

Figure 9: Shaft 6-W

Figure 10: Shaft 11-P65

Figure 11: Shaft 9-B50

Water shaft 6-W (Figure 9) was cast as a control and demonstrates a generally uniform profile between samples. The close grouping of the data shows consistency in the concrete strength profile which was expected in the control samples. Polymer shaft 11-P65 (Figure 10) showed similar consistency.

Figure 11 shows the average strength profiles for specimen 9-B50 ranged from 3200 to 7000psi. While more samples need to be cored to corroborate the noted trends, the conclusion currently drawn is that the bentonite shafts did not yield uniform strength profiles and that the concrete strength is reduced in the cover region.

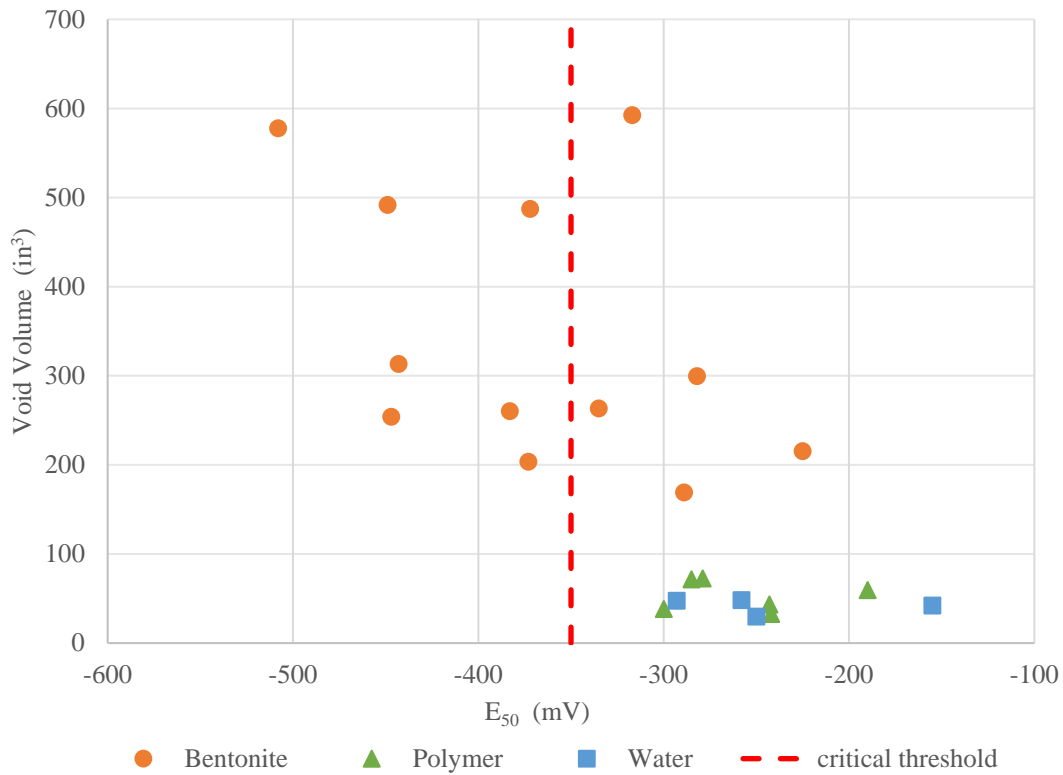
Figure 12: Void Volume vs. E_{50} Potential for all shafts

The average E_{50} potential values for all water, polymer and bentonite specimens were -239, -257, and -373mV, respectively. This confirms corrosion protection for water and polymer specimens but highlights the original concerns about the cover quality of bentonite shafts. Seventy percent of all bentonite specimens exhibited E_{50} surface potentials below the -350mV corrosion threshold and 92% of bentonite samples exhibited localized critical potential values somewhere in the measured data field. The bentonite shafts exhibit a general trend between E_{50} potential and surface void volume (Figure 12) wherein the potential becomes more negative as the void volume increases. No specimens were subjected to chlorides which can exacerbate low surface potentials, yet the steel in these shafts was actively corroding. Further, computations for life span expectancy from corrosion protection assume homogeneous cover material which is invalid as soon as cracking or any other chloride pathway is provided.

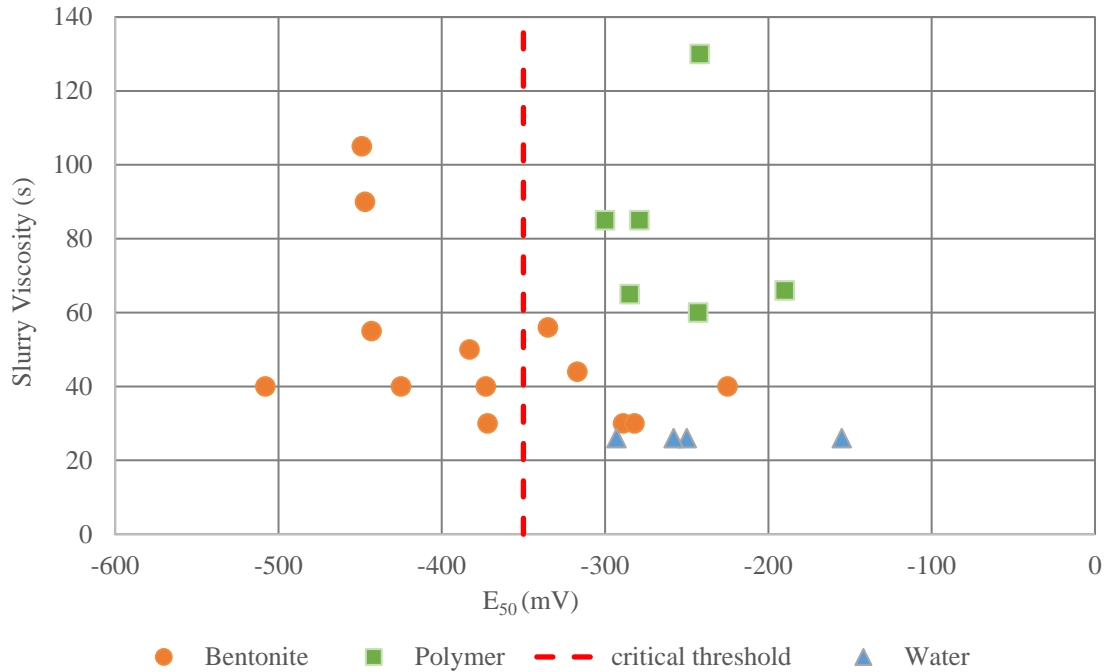
When considering the effects of viscosity on cover quality, Figure 13 shows that the critical corrosion potential was observed for all values of viscosity for the shafts constructed in bentonite slurry. This suggests that the mere presence of bentonite slurry as the concrete flows through and around the rebar is enough to compromise durability.

Figure 13: Slurry Viscosity vs. E_{50} Potential for all shafts

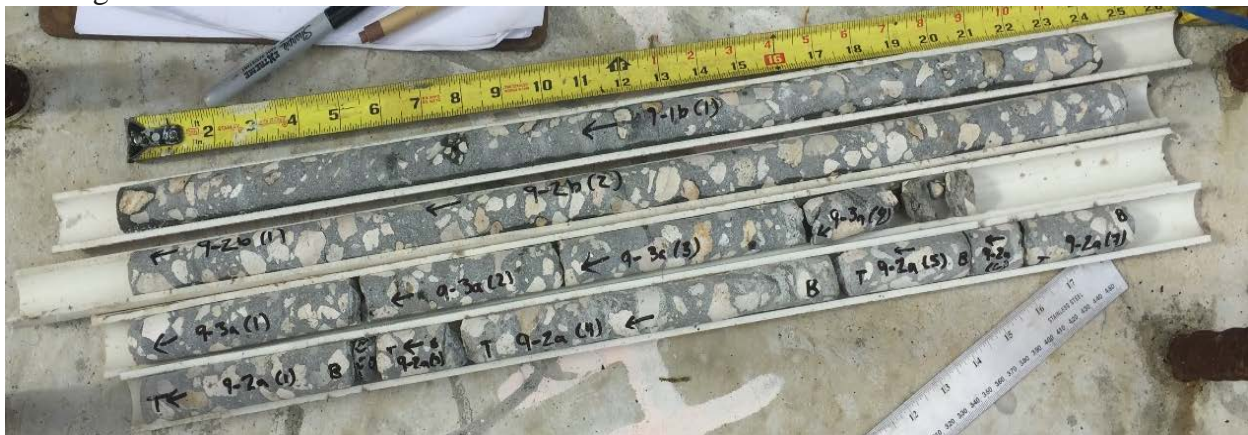
Figure 14: Cores extracted from Shaft 9-B50 (bottom two specimens extracted from the cover region)

The average concrete strength in the cover of the water, polymer and bentonite shafts were 4465, 5586 and 4116 psi, respectively. The modest variation in strength indicated that the concrete quality between laitance creases was relatively unaffected and the coring only encountered trapped laitance intermittently. These thin lenses did not significantly affect the average strength. However, where 100% recovery was observed for all shafts, cores from bentonite shafts were a collection of short lengths where breaks corresponded to the exact horizontal crease locations (Figure 14). All water and polymer cores were full length and unbroken. When considering cracking moment computations a matted shaft is essentially already cracked resulting in a cracking moment of zero.
