Work underway at  
seepage cut-off wall  
for Wolf Creek Dam

## 2013 OPA Winner: Wolf Creek Dam Rehabilitation

Michael F. Zoccola, P.E., USACE and Fabio Santillan, TSJV project manager, Treviicos

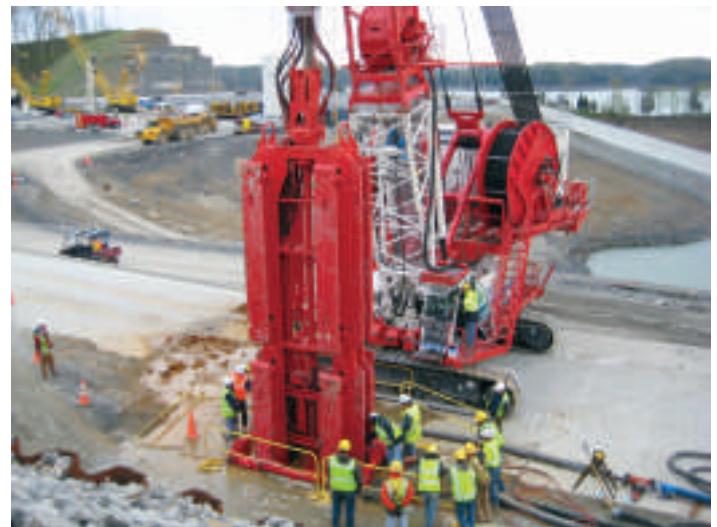
The hydromill is inserted into a steel guide frame locked into guide walls on the work platform, allowing the mill to begin excavation at the right location in a vertical position

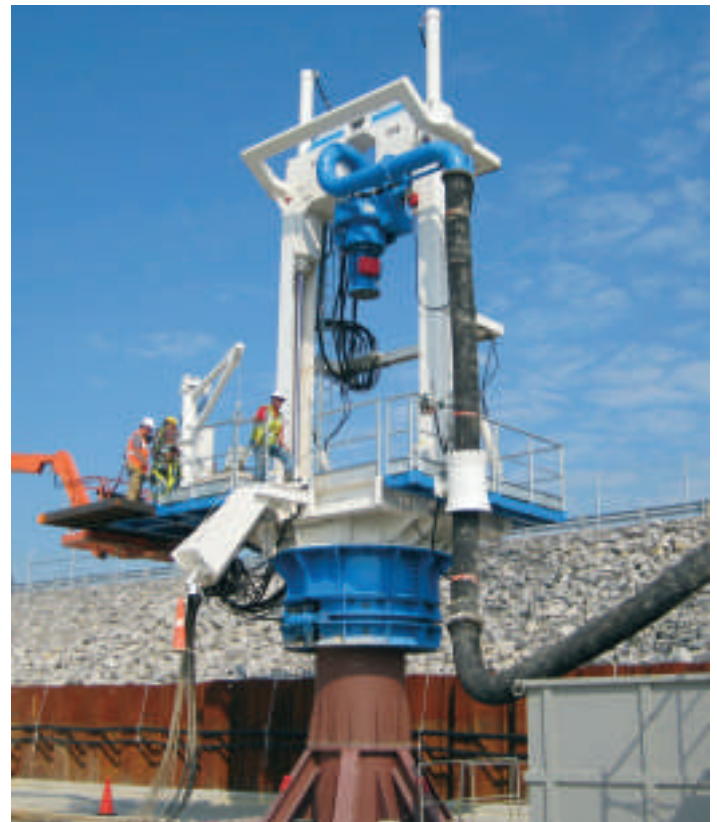
**The Wirth drill being installed atop casing bolted to the work platform at surveyed locations**

Piles were installed using a Wirth drill rig. The bottom hole assembly of the drill has a roller rock bit face that was fitted with a 2 ft (0.6 m) stinger to fit inside and follow the guide hole. The bottom hole assembly on the Wirth had on-board inclinometers that provided verticality data to the operator. The Wirth drill had no steering capability. It relied on the stinger to follow the guide hole, the 60 ft (18.3 m) long bottom-hole assembly riding inside the pile hole, and the dead weight (~ 70 tons) to maintain the location and
